REPORT TO COUNCIL

SUBJECT: Preliminary Flood Damage Assessments with Repair and Mitigation

Estimates

Preliminary Flood Damage Assessments with Repair and Mitigation Estimates

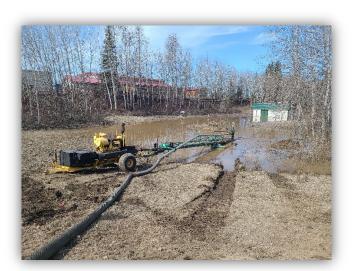
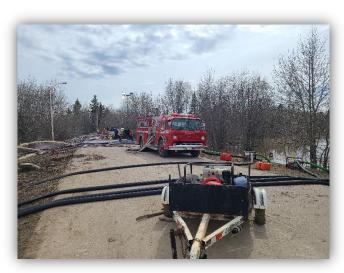
TOHR Affected Asset(s): Roads, ditches

Riverview Drive, which is currently entering phase two of construction as a capital project for the Town, was breached in two locations, resulting in the stripping away of surface and base aggregate and significant flooding of the ravine

Cleanup & Repairs: Hundreds of hours of labour and pumping from internal and contracted services/ equipment were required to clear water from the ravine and allow access to the lift station (pictured above). Cleanup required will involve removal of debris and road materials from ditches and placement of a new granular base.

Mitigation Recommendations: assessments have been initiated to determine implications of raising the road elevation as scheduled construction is beginning for the 2022 season.

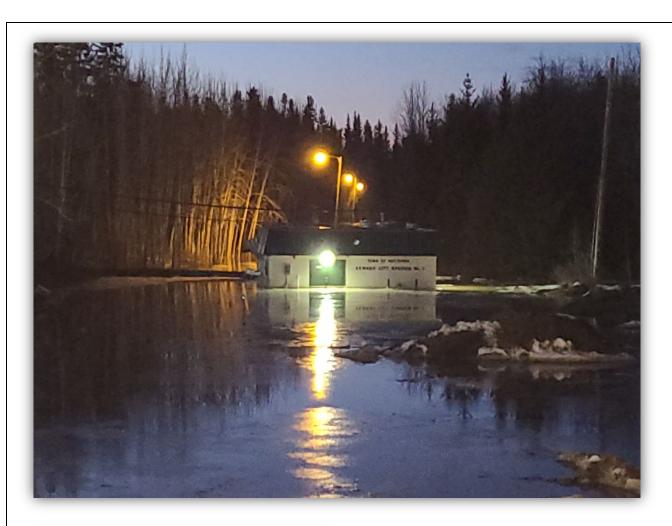
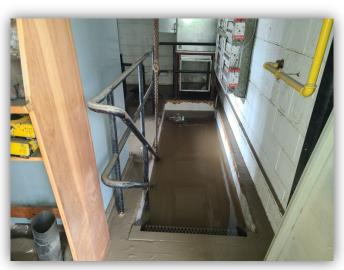
Sewage Lift Station #1 located on Riverview Drive is currently the largest capacity lift station in the Town collecting sewage, servicing Mcrorie Rd in the south to the West Channel Bridge in the north. During the spring flooding of 2022 the Lift Station was submerged in 2.3 meters of water and sustained considerable damage to all the equipment in the building. Items include:

There was not any damage to **sewage lift stations 2,3,6**; however, significant flooding did occur in each of these locations and cleanup activities were needed.

Cleanup & Repair: Lift Station 1 repairs and assessments are ongoing despite being operational through reduced capacity and redundancy as of June 2022. A detailed engineering assessment through Stantec will provide guidance to the Town in terms of replacement vs repair.

Lift stations 2,3,6, & Beaver LS had been cleaned by Town staff.

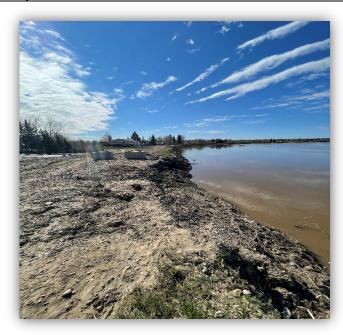
TOHR Affected Asset(s): Bank/Berm

Alaska Road is built along the top of the berm in the West Channel area of Town and provides access to a number of residential properties as well as the West Point First Nations band office. During the flooding, this section of the road sustained damage due to high water levels and ice flow in the channel. The 2022 flood caused the bank to slough away and cave into the channel.

Cleanup & Repair: Recommended option for repair includes a sheet pile wall along the river side of the road berm in the area of potential danger with reconstruction of the road to occur afterwards.

Estimated Cost of Repairs: 1,300,000	Estimated Repair Completion: 2023	Repair Funding Source: Disaster Mitigation and Adaptation Fund
Mitigation Recommendations: Mitigation included in scope of repair work.

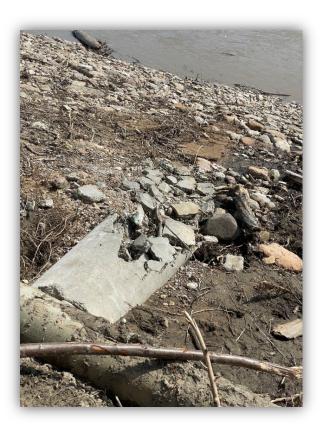
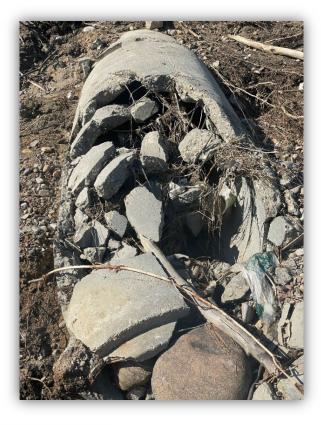
There are 10 storm outlets in town that empty onto the riverbank. Each outlet was damaged to some extent as ice pushed into the bank stripping away cover/overburden and exposing significant portions of pipe. In addition to the storm outlets, the gate valve for the ravine was damaged. River water flooding into town entered the storm sewers, leaving behind large deposits of silt.

Cleanup & Repair: Further assessment of damage is required; however, repairs will be extensive and will require flushing/camera work, armoring, replacement of headwalls, and replacement portions of storm pipe. Additional maintenance and cleaning of storm sewer was necessary in the aftermath of the 2022 flood.

Estimated Cost of Repairs: \$670,000.00	Estimated Repair Completion: 2024	Repair Funding Source: DAP
Mitigation Recommendations: setback of outfall; armoring of headwall and bank to provide protection against further erosion and ice damage.	Identified funding source	ces: TBD, MACA
Estimated Cost of Mitigation: \$100,000	Estimated Repair Completion: 2024	Repair Funding Source: DAP

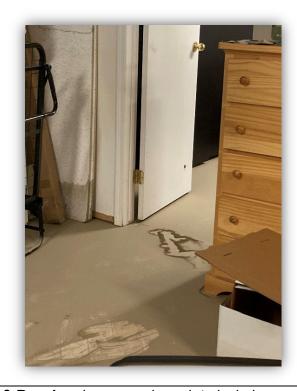
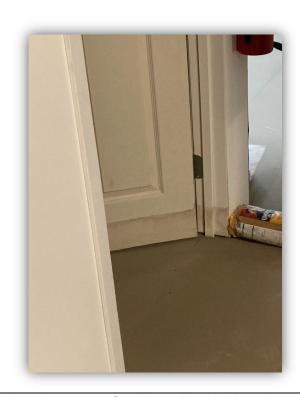
TOHR Affected Asset(s): Town Owned House

Sewer backup resulting from the 2022 flood (\sim 6" – 8")

Cleanup & Repair: cleanup and repair to include removal and replacement of wall panels, shelving, dry wall, insulation, vapor barrier, and doors.

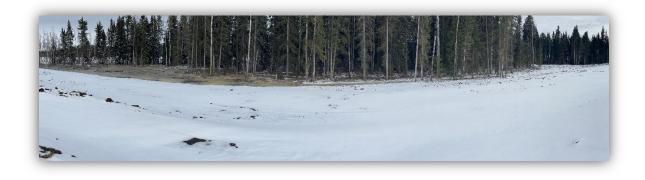
TOHR Affected Asset(s): Fraser Place

Fraser place is in the beginning stages of development and although the few lots affected by the flood had already been identified to be in the flood fringe zone, it is recommended that the lowest designed elevations be raised to mitigate future impact.

Estimated Cost of Repairs: \$0	Estimated Repair Completion: n/a
Mitigation Recommendations: Raise the elevation of	Identified funding sources: ICIP
lots with costs incurred due to engineering, design, and	
aggregate.	
Mitigation Cost: \$110,000	Estimated Completion: Q4 2022

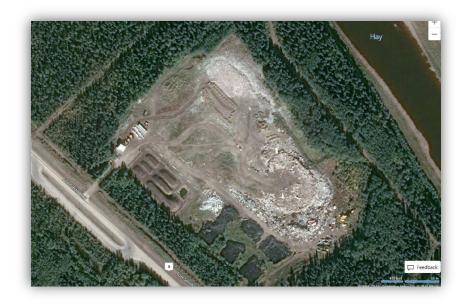
TOHR Affected Asset(s): Solid Waste Facility

The lifespan of the Hay River landfill has been a concern in recent years and the 2022 flood event has accelerated this decline significantly. An approximate airspace of 4000-4500 m³ is taken up within the landfill each year due to normal operations and a large amount of diverted material from cleanup and abatement is anticipated to increase this number substantially. Associated operational costs at the landfill to accommodate in influx of garbage was and continues to come at a cost. With limited years remaining at the Town's landfill, and in consideration of increased regulatory requirements and access to land for a new facility, solutions are few and far between. Operational requirements to divert material and conform to regulation will be ongoing and costly as the impact on the facility is substantial.

Cleanup & Repair: Diversion, hauling of cover material to site, placement of material, additional sampling of bio pad/retention pond, repairs to access roads, and significant improvement to landfill working face and steep embankment of garbage surrounding.

Estimated Cost of Repairs: \$310,000	Estimated Repair Completion: Q3 2023	Repair Funding Source: Disaster Assistance Policy	
Mitigation Recommendations: permanent scale for	Identified funding sources: Disaster Assistance		
more accurate record volume received.	Policy		
Mitigation Cost: \$60,000	Estimated Completion:	2022

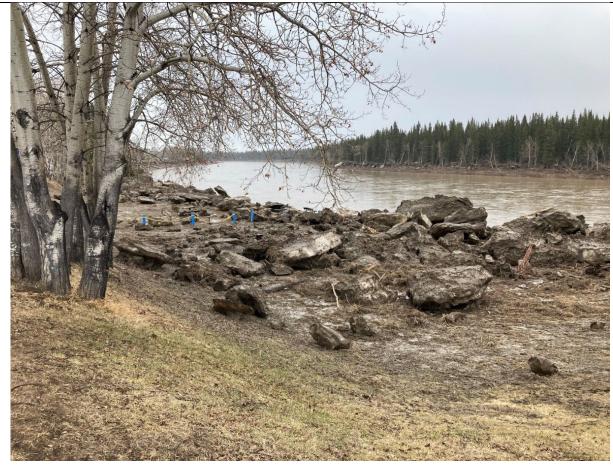
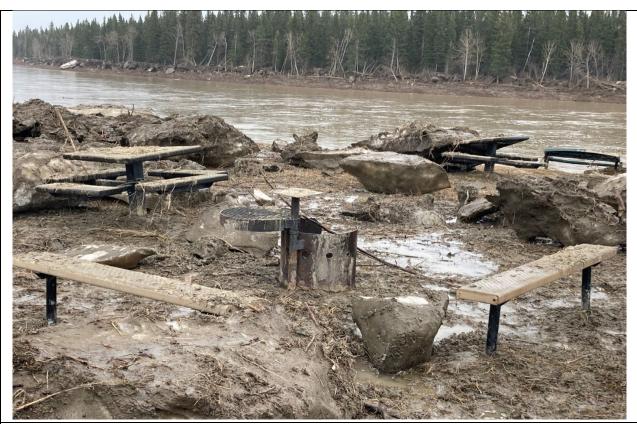
Bob McMeekin is a signature greenspace at the entrance to town, on the banks of the Hay River. The park has some elevation changes and was only impacted by flooding and ice in lower lying areas that are closer to the river. The sliding hill, picnic area, boat launch and low mobility parking area are all situated in lower lying areas.

Complete list of flood impact:

- 2'-3' feet of mud, driftwood and debri in parking area 2
- erosion of surface aggregate in parking area 2 and boat launch
- · 2 picnic tables damaged by ice
- 2 firepits flooded and impacted by ice
- 6 park benches damaged and/or dislodged by ice
- Light pole knocked down
- Power line cut at light pole #2
- Debris, mud and driftwood on sliding hill

A local contractor was hired to address erosion of the parking area and access roads. THR Recreation Maintenance staff will clear and remove remaining debris and silt from the sliding hill and lower lying areas when ground is dry enough to access with equipment. Park furnishings will also be removed as soon as possible.

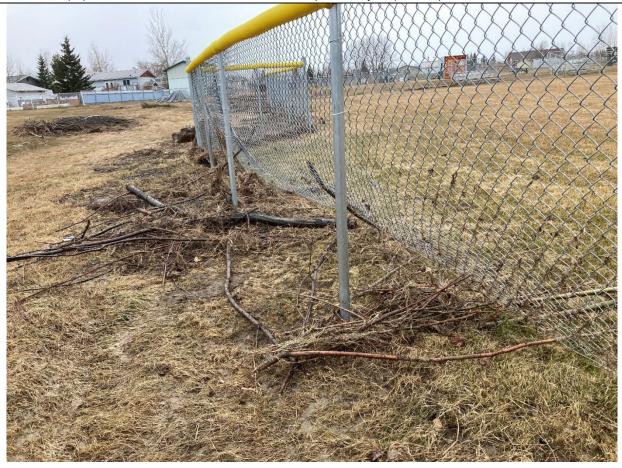
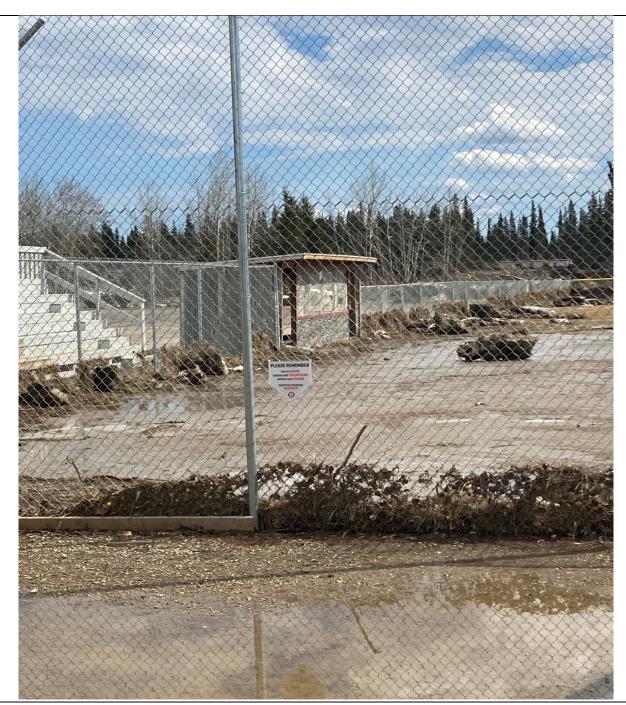
2. Glenn Smith Field

- 200' of outfield fencing detached and posts leaning
- grass and debris on outfield and left field fence (400' length x 4' vertical)
- parking area little to no debris but erosion of surface aggregate
- infield standing water and significant erosion
- player benches flooding, mud and debris (3' vertical water line)
- mud and debris in beer garden area
- equipment shed to be assessed further (not likely impacted)

Sport field reopened and user groups making use of field. Cleanup and brushing of treeline will continue in June. Further work required to repair infield erosion and establish proper drainage – see additional mitigation measures below.

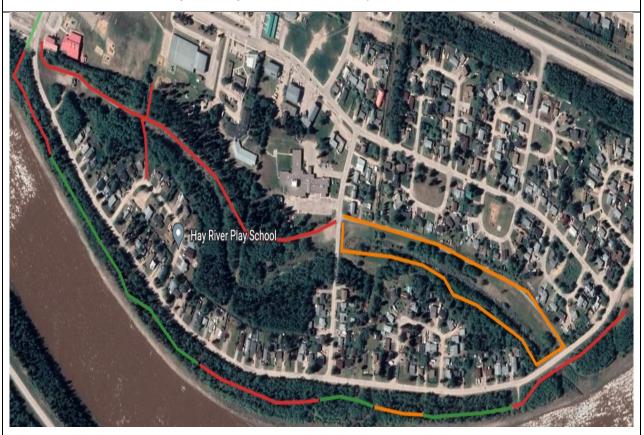
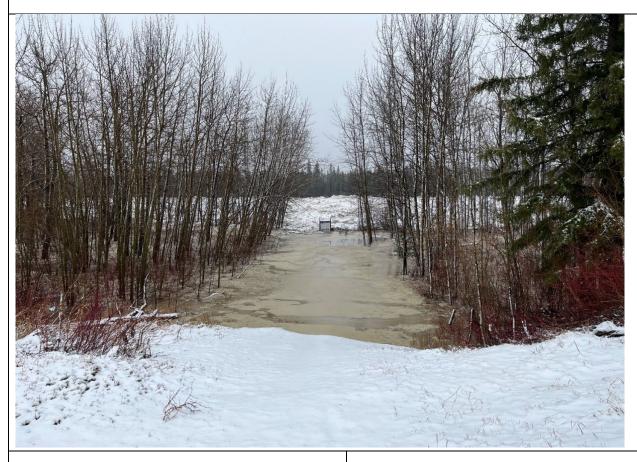
- 4 lower lying sections heavily impacted and remain impassable or hazardous
- Approximately 1.3km of trail with 2'-4' feet of mud, driftwood and debris remaining
- Dangerous leaning trees and broken branches to remove
- Erosion of surface aggregate and trail sub-base in several sections
- TCT interpretive sign damaged and displaced by ice

Ice has melted or been removed, and mud has dried up. Silt remains on most of the trail and will need to be removed with use of tractors, ATVs and Town labour. Three sections of the trail remain impassable due to the amount of debris deposited on the trail. Heavy equipment and experienced tree fellers are required to clear those sections.

- Raise grade of surface
- Improve drainage via additional ditching and repairs to existing
- Include erosion control measures such as weeping tile

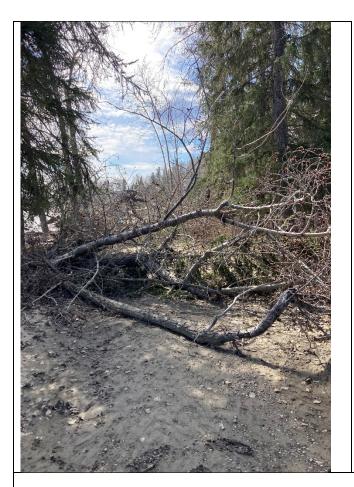
June 23, 2022

Trail expected to remain closed until further repairs are performed on lift station 1.

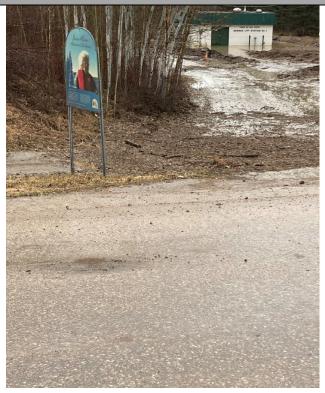
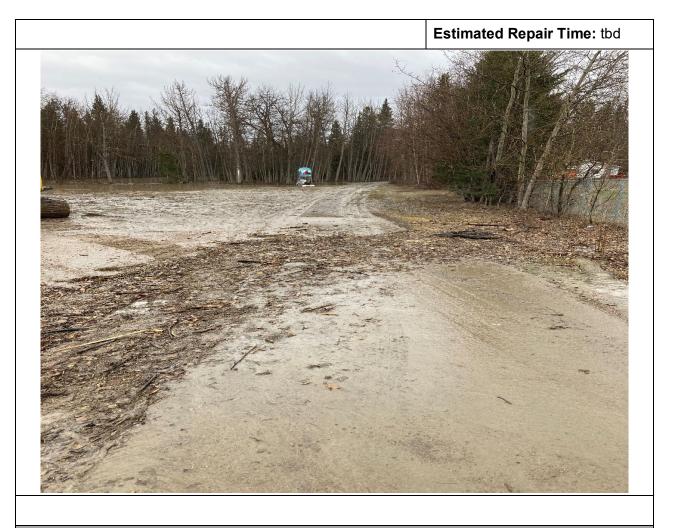
4. Irma Miron Trail

Trail was completely submerged while ravine was flooded.

Trail remains closed due to heavy deposit of silt and environmental waste during closure of lift station 1.

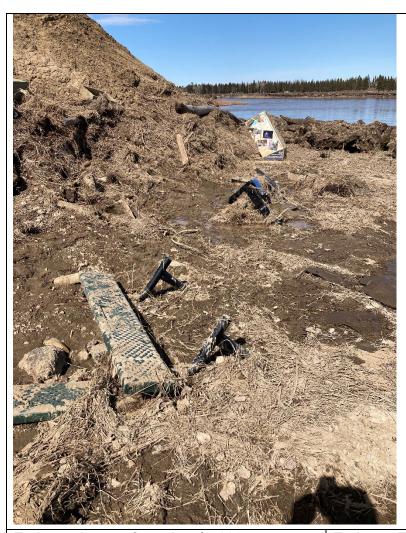
5. KFN Ice Crossing Day Use Area

Park bench and picnic table damaged and displaced by flooding and icebergs.

Replacement required at estimated cost :

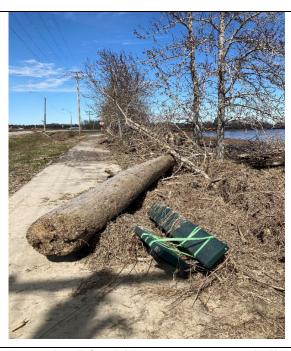
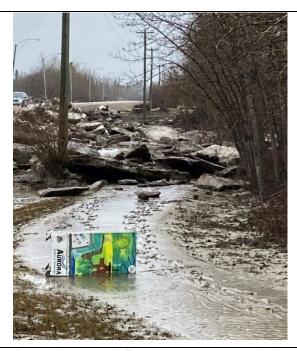
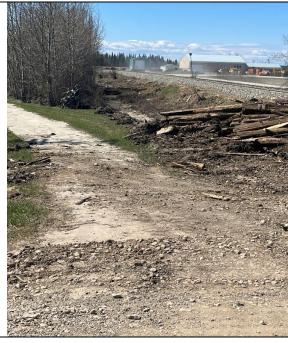
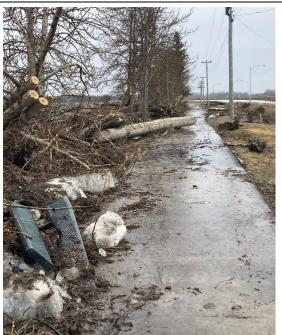
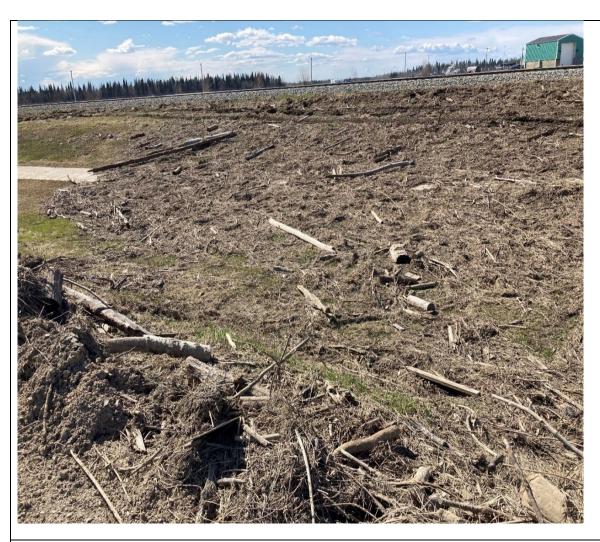
Four sections of the trail were heavily impacted by water and ice during peak flooding. Silt, driftwood, ice, and debris were deposited onto approximately 1.5km of trail.

Trees and trail furnishings were uprooted, displaced, and damaged. Four benches, two picnic tables and two bearproof garbage bin were damaged and will need replacement. Tree removal is underway and will require weeks to complete.

Ice has melted or been removed, and mud has dried up. Silt remains on most of the trail and will need to be removed with use of street sweepers and high-pressure watering. Three sections of the trail remain impassable due to the amount of debris deposited on the trail. Heavy equipment and experienced tree fellers are required to clear those sections.

Asphalt resurfacing will be required for several hundred meters of the trail that were impacted by heavy equipment used to repair road and rail washouts. Once initial cleanup is completed, paved surfaces will be assessed further to determine how much resurfacing is required.

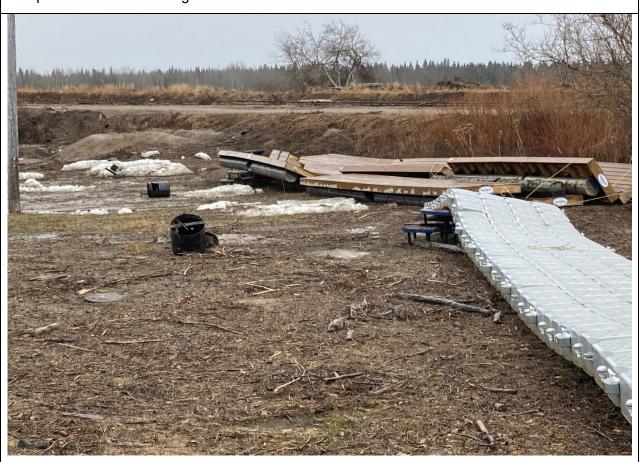
Park furnishings were not damaged but there was surface damage to wood finger dock sections and plastic modular docking.

THR Recreation Maintenance staff have cleared and removed the majority of debris and silt from the boat launch, parking area and access roads. A local contractor was hired to address erosion of the parking area and access roads.

Park furnishings and docking were relocated and installed as per seasonal start up routines. Repairs required to finger dock surfaces and structure will likely be performed by THR staff.

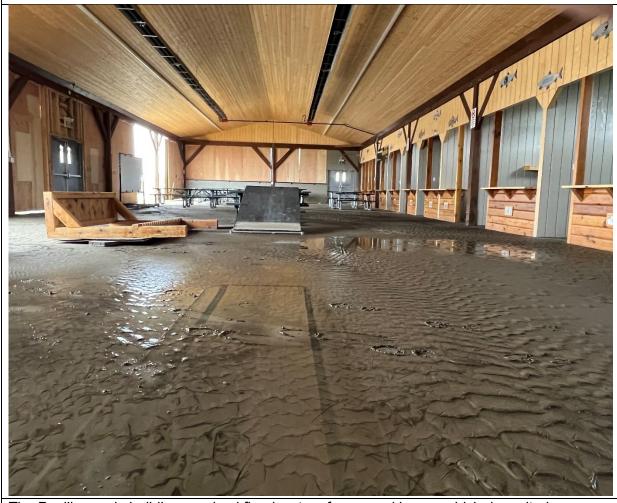
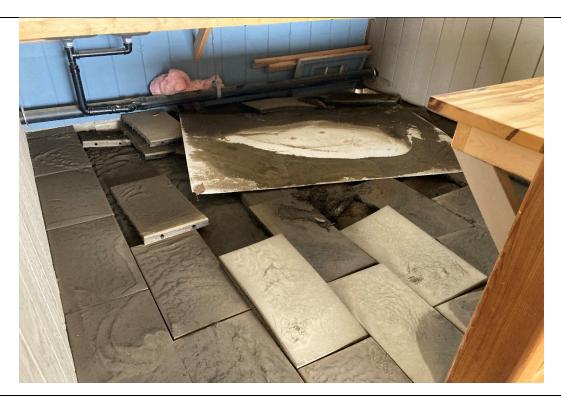
9. Fishermen's Wharf Pavilion

The Fishermen's Wharf Pavilion was submerged in rushing waters during 2022 flooding. The parking area and building were heavily impacted by water and ice which breached the sheet pile retaining walls.

The Pavilion main building received flood waters for several hours, which deposited approximately 2" of silt throughout. The main building was assessed by the Town's insurance adjusters and it has been thoroughly cleaned via an abatement process. Wall panels and drywall and floor tiles have been removed in all booths. All remaining materials were not impacted and the building is drying until contractors return on June13th to begin repairs.

Significant flooding impact was observed in the main building booths, as well as the detached secondary building, due to water eddying in and around corners. See image below.

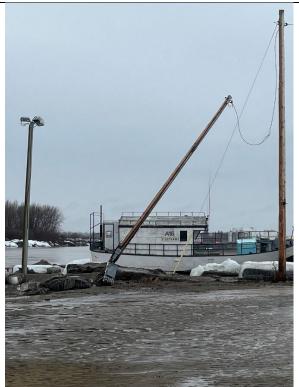
The parking area was eroded considerably, FWP parking barricades were pushed over and displaced. Three sea cans, flower planters and other furnishings were also displaced during the peak of flooding. Silt was also deposited in 2'-3' high mounds at the northeast corner of the parking lot.

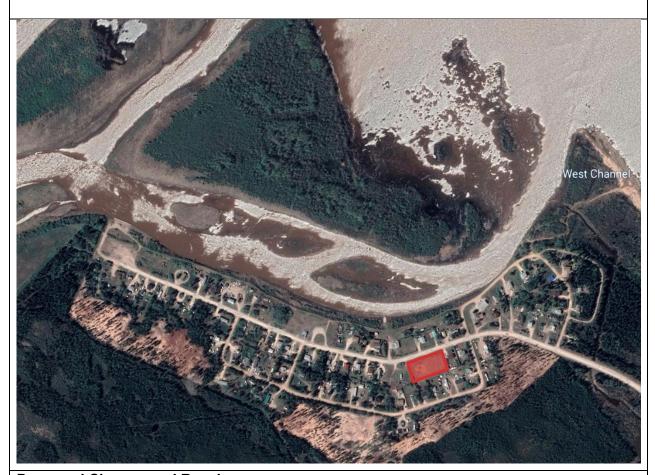
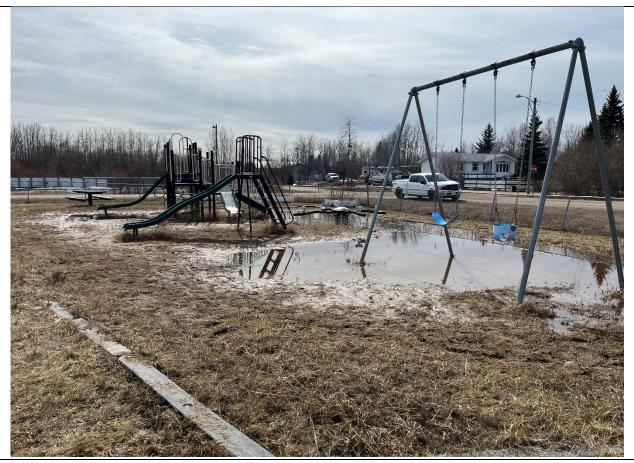
The park was severely impacted by high water levels, rushing waters and large chunks of ice. The fencing was broken, pushed over and damaged by water and ice around most of the perimeter. The parks soil and playground fall zone remain saturated with water and littered with debris all of sorts and sizes.

Proposed cleanup and recovery for the greenspace include removal of demolition of current fence, removal of current playground equipment, removal of debris with heavy equipment, raising the grade of the park, addition of berms for erosion control and flooding prevention, replacement of fencing and playground equipment.

Haul and place fill to east and south edges of greenspace to act as landscaped berms that would prevent erosion and flooding. The landscaped berms would also serve as amphitheater seating for gatherings and viewing of performances at the greenspace.

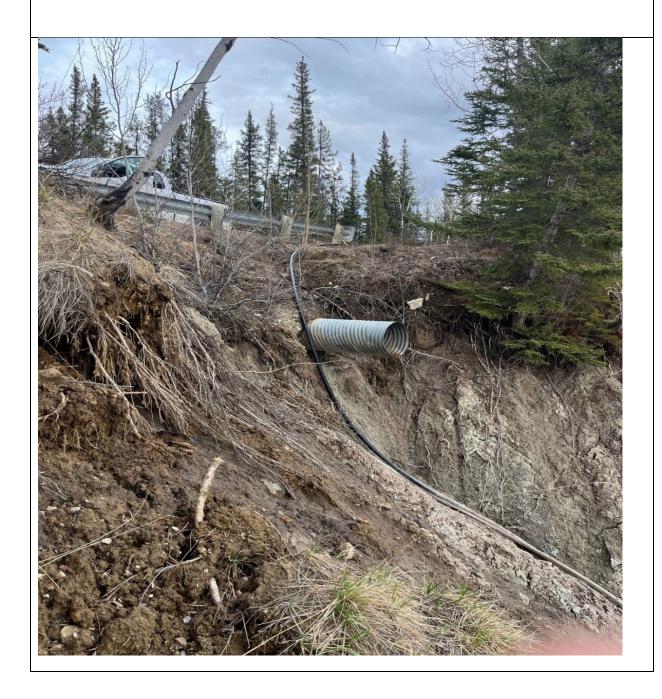
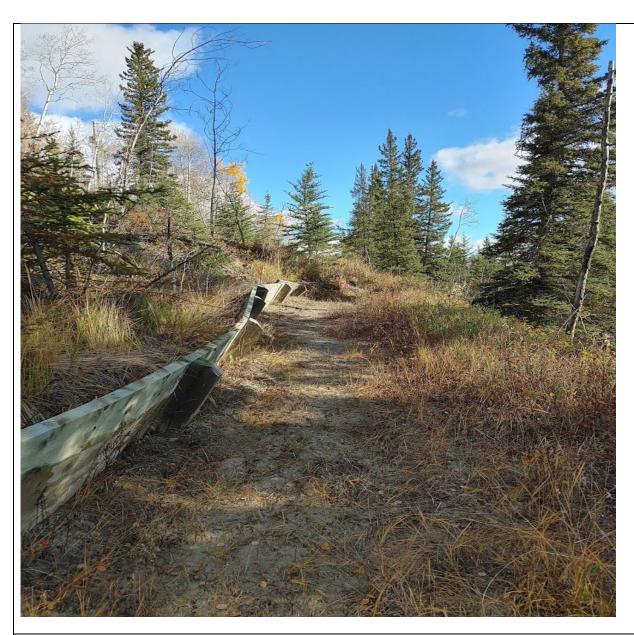
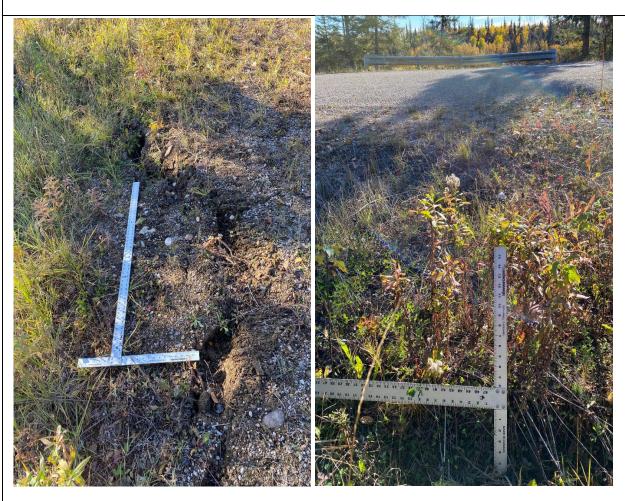
The road shoulder and ravine slope have eroded significantly in places as result of improper drainage ditches and culverts. The proposed access road repairs would include chip seal repair, road surface refurbishment, drainage improvements, and other general access road construction work.

A drainage survey will be used for repairs and improve gradation, ditch shaping, culvert quantity and culvert sizing. Following the drainage improvements, road repairs will include:

Realignment away from the riverbank is being explored as a possible long-term solution. Realignment would use the current highway access point but redirect Hoffman Way behind the current campground and golf course driving range. Scope of work includes tree clearing, removal of organics, ditching, establishment of proper road base with asphalt surface.

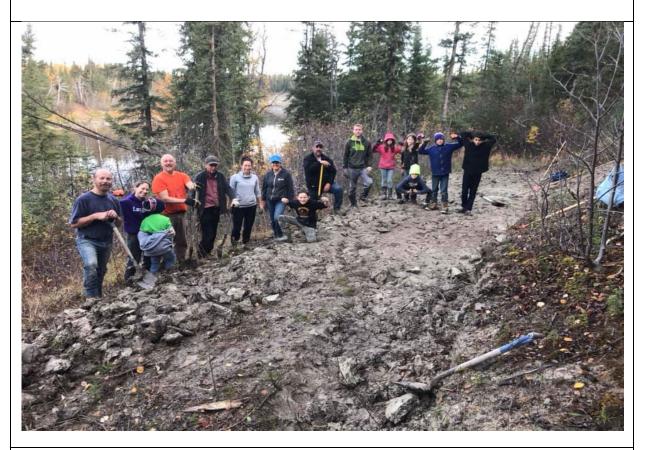
There may also be damage to some of the poles supporting trail lights. Further assessment is required, which should also allow trails to dry out enough for heavy equipment to access.

There was a washout of maintenance road that angles down to provide river access for the ski and golf clubs. The Golf Club used that road in the past to access the river to pump water up to fill the pond b/w 6 & 7, as well as provide water to the sprinkler system on the lower holes whenever the upper irrigation was not functioning.

Riverbanks have eroded significantly across the river, which has blocked access to the continuation of the Brendan Green Trail. Other trail sections that have similar low spots have been impacted similarly by erosion and trees being knocked down.

Removal of obstructions and hazards to reopen trails and ensure safety, accessibility, and usability of trails. The work will be completed by contractors with some support from Ski Club volunteers. Contractors would perform a one-time mechanical brushing and mulching to eliminate any potential hazards to users, and their equipment, opening trail width to 12 feet wherever possible. Volunteers would help with prep of trails, cleanup, and installation of appropriate signage, including trail markers once work is complete (as per picture above).
